# Reader Noise and HID® Mercury™ Wiegand Behaviour Technical Bulletin

PLT-06868, A.0 **December 2022**

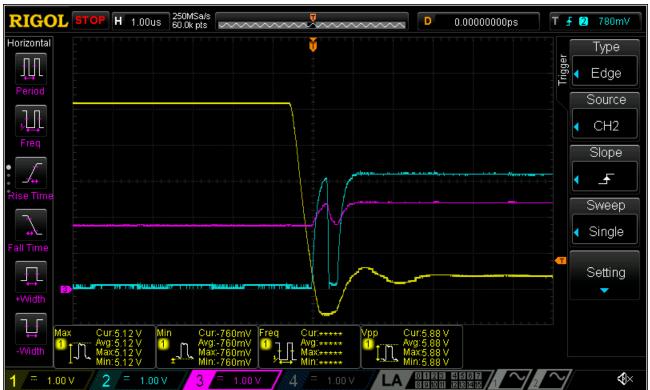
Readers and cables producing a substantial negative voltage output, in certain instances, are causing invalid card reads on certain LP1501 controllers.

The variability of this issue is influenced by a combination of factors such as the speed of Wiegand switching by the readers, cable type/length, and some variability in the detection circuit of the LP1501. In the below image, the reader output (yellow) drops well below 0V causing a toggling of card data (blue line goes up, then down, then up) which the controller picks up as extra card data.

Add series resistors (suggested starting value of 50 ohms) to both D0 and D1 Wiegand data lines at the reader end. The added resistance slows the falling edge pulse transition and reduces transmission line effects.

Reconfigure and rewire readers and controllers from Wiegand to RS-485/OSDP communication.

In cases with the impacted Schlage readers, the issue was mitigated by changing the Wiegand pulse from 100us with 1 ms separation to 40us and 2ms separation via a config card. When experiencing this issue with a non-Schlage reader consult the reader manufacturer for more information on how to alter the reader's Wiegand pulse settings.

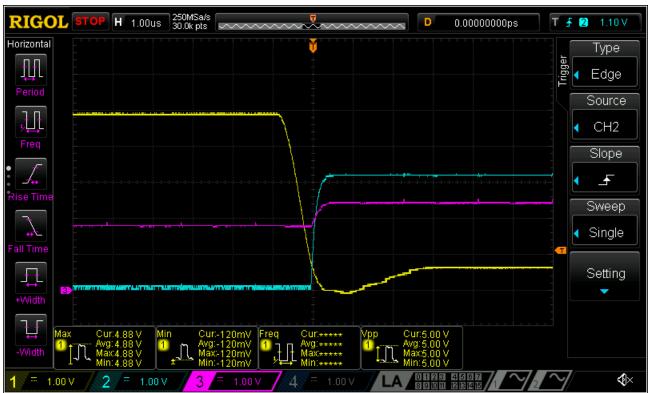
Figure 2. HID Signo reader with proper voltage output

In the below image, the HID Signo reader Wiegand output (yellow line) does not drop below 0V, and does not cause toggling of card data (blue line goes high only once).

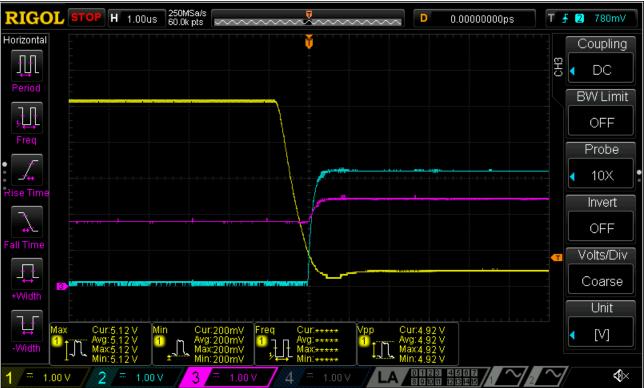
Figure 3. Schlage MT15 with series resistance added

In the below image, the 50 ohm resistors are installed in series at the reader end of the same Schlage MT15 reader from Figure 1. This resistance keeps the reader output voltage from dropping below 0V.
